THE CANTERBURY EARTHQUAKES: Answers to critical questions about buildings

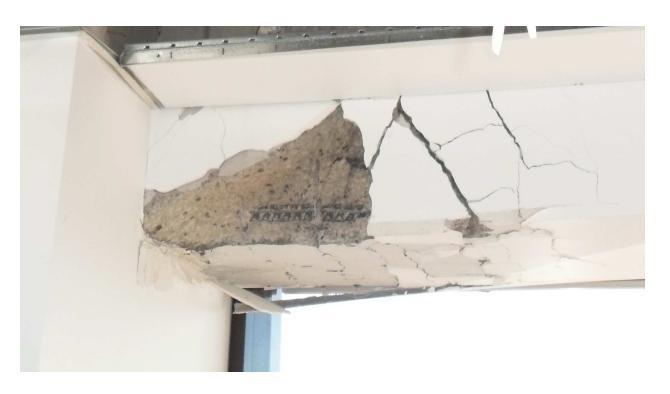
Figure 1: An energy absorbing (ductile) beam hinge in a reinforced concrete building after an earthquake. As these ductile elements yield they absorb energy without loss of strength that would lead to collapse of the building. While some of the cover has fallen off, none of the reinforcing has broken, and the concrete inside the reinforcing cage is intact, so this beam can still carry load.

- Providing "stiffness" so that buildings do not move much in small earthquake shaking and there is no damage.
 - Providing "strength" so that buildings do not have any significant damage to the building frame in moderate levels of earthquake shaking.
 - Providing "toughness" so that buildings do not collapse under more extreme earthquake shaking, such as that considered in the design code of the time. This toughness is the ability to absorb energy is called "ductility". As the building absorbs energy, damage occurs without collapse.

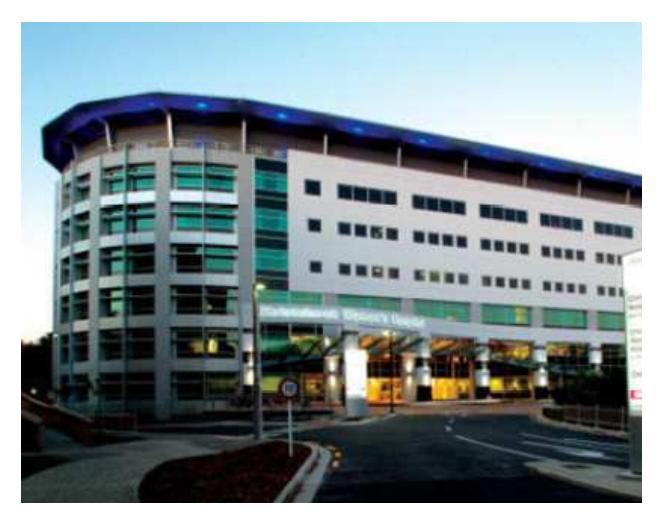
Figure 2: Christchurch Women's Hospital sits on Lead Rubber base isolators.

Lead rubber bearings, as deployed at Christchurch Women's Hospital (Figure 2 & 3), Parliament and Te Papa, are an example of a novel device developed by the former NZ Department of Scientific and Industrial Research in order to protect structures against severe ground shaking. This is called base isolation, because it allows the ground to move horizontally beneath the building thereby isolating the structure from the ground and significantly reducing the forces on the building. Te Papa's base isolators can be seen as a special exhibit just around the corner from the museum's main entrance.

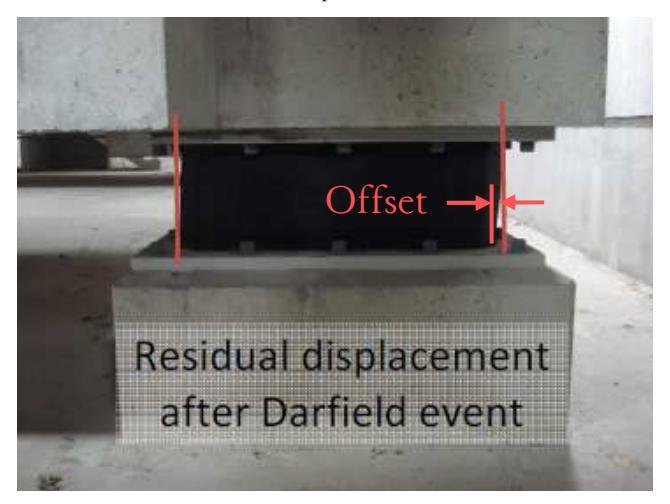
Figure 3. Lead Rubber base isolator under Christchurch Women's Hospital, showing the final resting position of the building after its oscillation during the 4 September 2010 earthquake.

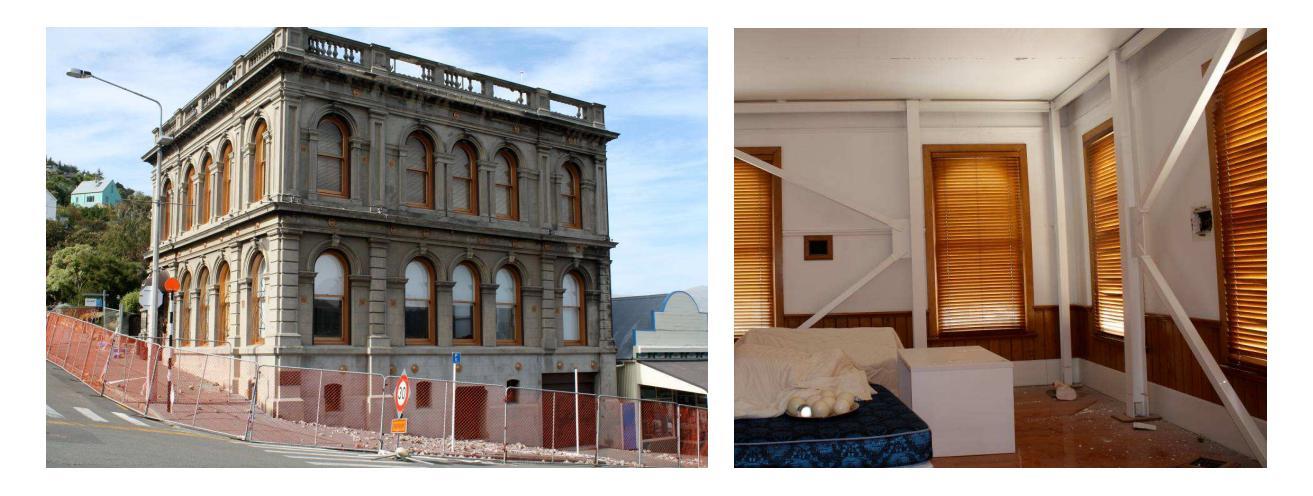
Figure 4: The Lyttelton Fire Station building suffered only minor damage as it has been strengthened with an internal steel frame (Photos Win Clark)

There has also been research on how to strengthen older buildings, and how to add further protection to vital buildings such as hospitals. Some of these methods include: removing particularly vulnerable parts of buildings (e.g. brittle façades and parapets); tying the walls together with steel bracing; bolting façades to the building's frame; adding new support structures; and, wrapping columns and joints with steel and other materials to keep them intact.

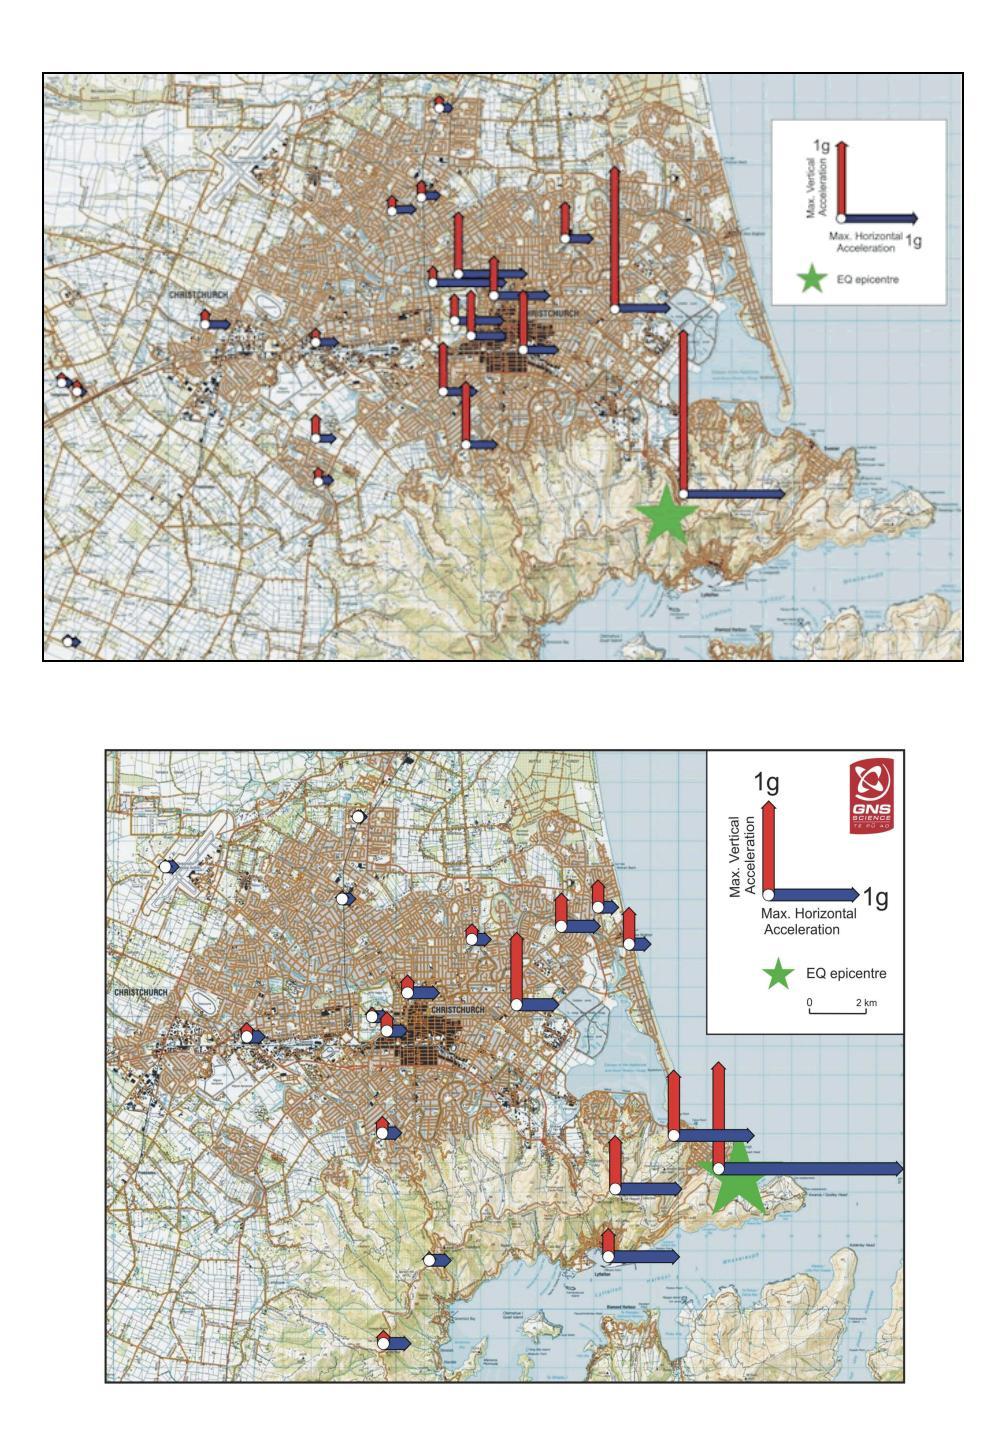
Figure 5a and 5b: Graphic showing the unusually high vertical ground accelerations in central Christchurch recorded during the magnitude 6.3 earthquakes on 22 February and on 13 June 2011. (Source: GNS Science)

Despite being only 6.3 on the earthquake magnitude scale, the proximity of the 22 February and 13 June 2011 events to the surface, and to Christchurch, caused ground shaking in the central business district several times as severe as what occurred in the magnitude 7.1 September 2010 earthquake (Figures 5a and 5b). The geology of the area made matters worse by guiding the shock waves towards the city. The peak ground accelerations, as they are called, were amongst the highest to have ever been recorded in a modern city anywhere in the world.

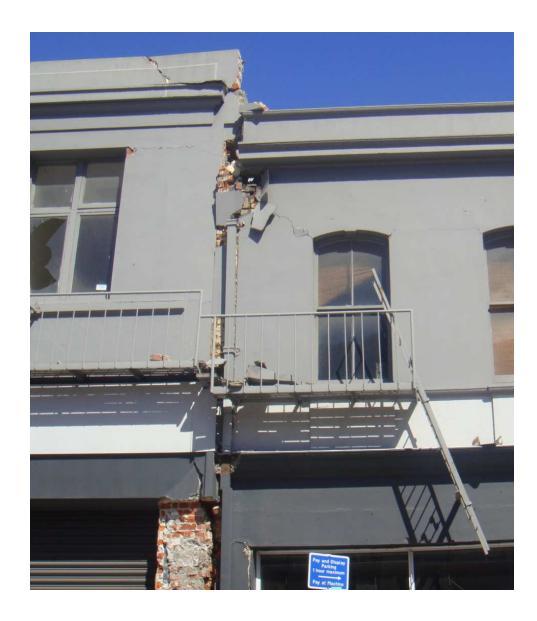
Figure 6: Pounding-induced damage of buildings in Christchurch CBD³

Other ways earthquakes cause damage to buildings include when two adjacent buildings collide as the ground movement makes them sway, causing pounding damage (Figure 6), or when sometimes, parts of one building—like parapets, chimneys or façade veneers—fall on another building and cause damage.

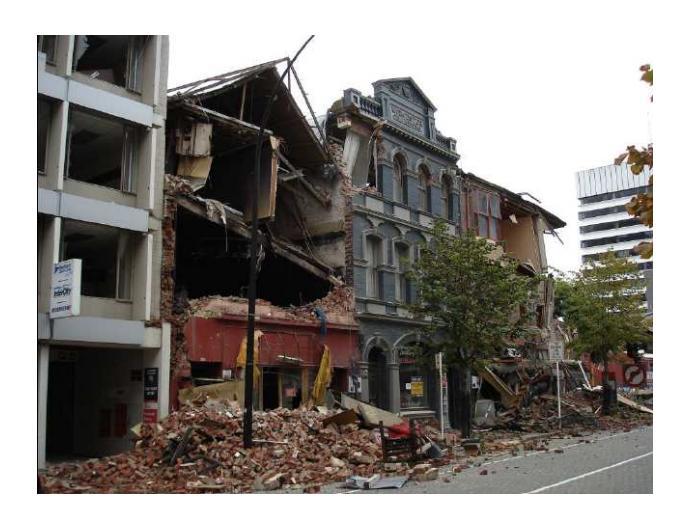
Figure 7. Former earthquake prone buildings.

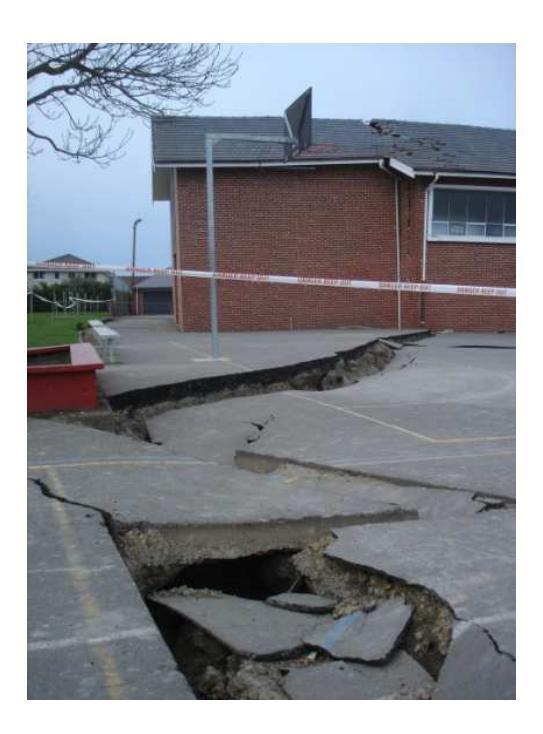
Figure 8 Lateral spread crack running through the courtyard and building at St. Paul's church, Dallington, Christchurch, New Zealand (September 2010)⁶

Most buildings did not collapse even though the levels of earthquake shaking were up to about twice the design level for buildings meeting the current code requirements. Even buildings in areas of liquefaction and lateral spreading, as well as strong shaking, did not collapse despite some being badly damaged (Figure 8) or left tilting.

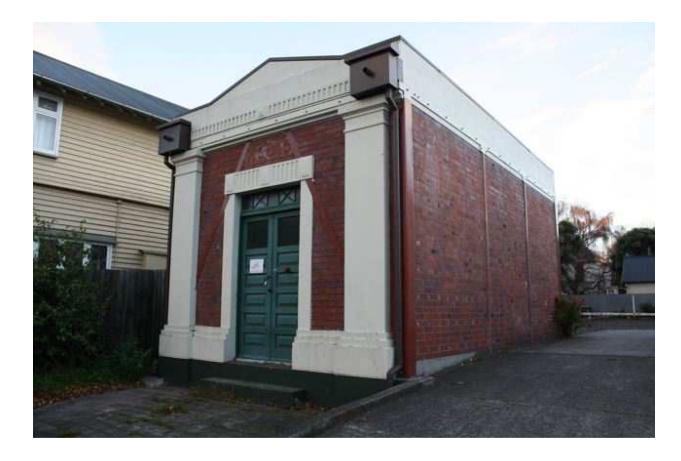
Just because a building is constructed in brick or stone, it is not necessarily a danger. If brick masonry is properly attached to a backing frame, as it is in most residential construction, it can behave well as can masonry blocks filled with concrete and strengthened with steel rods. Brick masonry restrained by a concrete or steel frame, if properly designed, can also behave well and it has been used effectively throughout the world, including Christchurch, as shown in Figure 9.
